# PROPERTY INSPECTION REPORT

Greenline Inspection Services INC.

3. Residence Type/Style

Built in: 1967

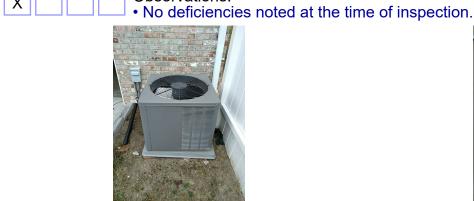
Inspect In	Not spect	Not Presnt	Repair Replac	Description: Air Cooled Central Air Conditioner • Rheem brand
Y				Observations:

Mfg. 2012
